Considerations on the preservation of ancient wall paintings by using the Infrared Thermography

Laura Fabbiano¹, Alessandro De Marco², Gaetano Vacca¹, Rosario Morello³

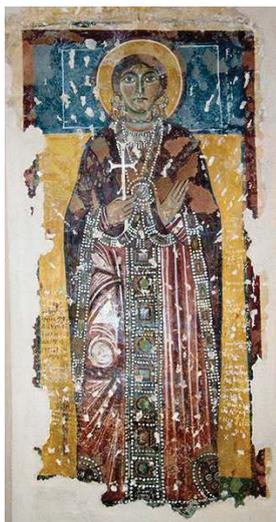
Fig. 2. Santa Barbara fresco.

Casaranello also houses numerous frescoes, some made in the Byzantine age (X - XI century), while others dated back to the Middle Ages (from the XII to the XIV century). The general state of the building appears to be satisfactory, and the recent refurbishment of the solar pavement and home automation of the windows for air recirculation, enhance its proper conservation. However, there are still some critical issues resulting from years of disinterest in the monument and the use or abuse that has been made of the church for many years. Artificial lighting is also an important critical factor. The spotlights date back to the eighties of the last century, and point their light beams directly onto the frescoes. Here we have taken as a first example for our study the fresco of Santa Barbara (Figure 2), realized on the second column to the right of the main entrance (Figure 3 and Figure 4).

The colors of the fresco are rather dull and almost faded. Contrary to what it must have been originally, in fact, the Byzantine frescoes always present themselves with intense and rather lively colors. A more accurate analysis of the physical state of the frescoed surfaces will also have to take into account the chemical composition of the different raw materials used.

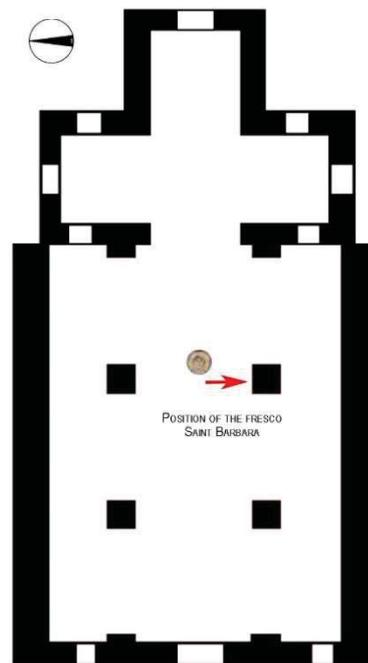
Present-day. the church has a plant with three naves divided by pillars joined by arches. A transept, not projecting laterally and in height, introduces, proceeding eastwards, to the presbytery and to the only apse, decidedly protruding and of rectangular layout, this latter obsolete in the early Christian period.

Fig. 4. Plant of the Church. The arrow indicates the location of the fresco of Santa Barbara.

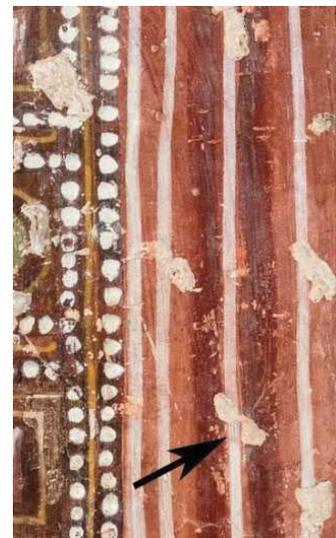
Fig. 5. Detail of the fresco of Santa Barbara

Currently the fresco has a staked surface (Figure 5).

These stakes are ancient and dated back to the eleventh century when the Byzantine rite was replaced (therefore the sacred images were hidden) by the Latin rite (new cycle of frescoes).

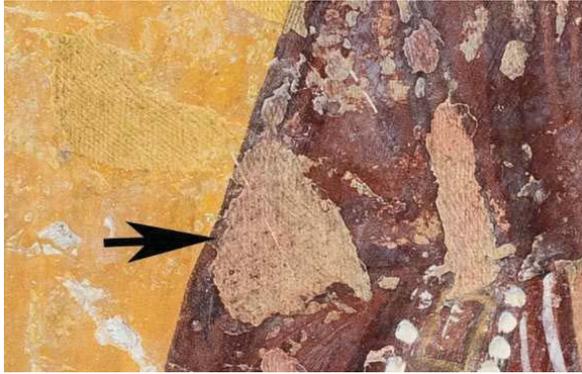
Fig. 6. Detail of the fresco of Santa Barbara

There are numerous visible additions on the fresco in question (but also present on almost all the frescoes in the church), made during the restorations (Figure 6).

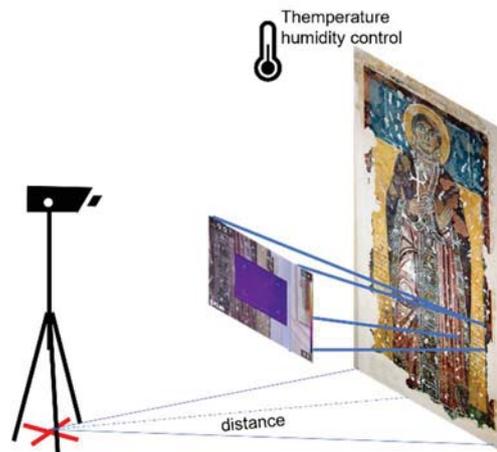
Fig. 7. First step of monitoring procedure

Figure 7 depicts the schema of the experimental setup; the distance between the thermal camera and the wall fresco is equal for each of the repeated and replicated experimental acquisitions obtained during the monitoring procedure.

The infrared camera used is a bolometer camera (Flir T1020, IR lens 28° , 36 mm) having a thermal sensitivity enough to detect temperature differences down to 20 mK , 1024×768 resolution, low noise, and a frame rate of 30 Hz .

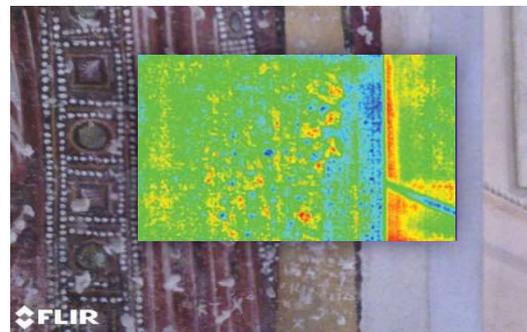
Fig. 8. First step of monitoring procedure

Figure 8, for example, shows the thermographic image superimposed on the photographic image of the specified zone. The representative thermographic image of the first measurement campaign is obtained by averaging pixel by pixels the thermograms acquired under repeatability conditions.

The thermographic image thus obtained will be compared with the homologous thermographic images acquired in the subsequent experimental surveys.

The monitoring, performed periodically (monthly for example), will therefore produce a series of thermographic images on which the regions of interest (ROI) are identified. The evaluated average temperatures of the ROI constitute a temperature map; the difference in temperature detected in the different monitoring maps of each ROI identifies the areas of the fresco that, during the monitoring period, have undergone a possible degradation.
